City of Hamilton

# 2017 Sign Support Inspections Summary Report

**Project No: 60554463**

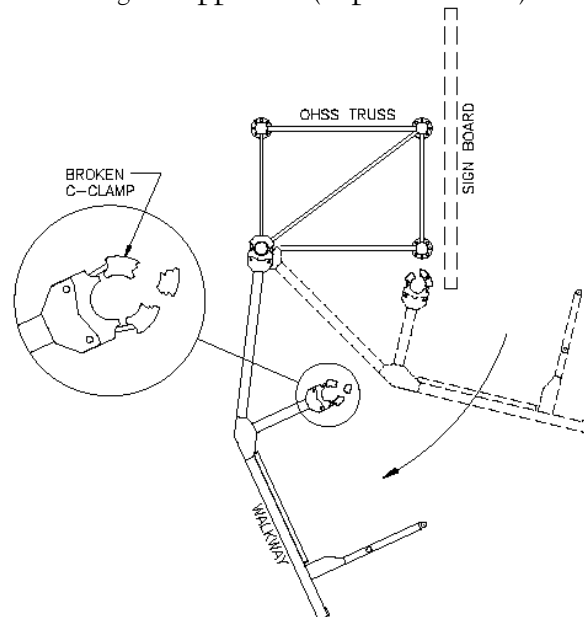
C-Clamps are used to support both the sign boards and the maintenance walkway. These clamps are constructed of a brittle casting and various factors result in cracking. These factors are: quality of casting, over tightening, imperfections of mating chord, and excessive structure movements/vibrations. The most critical C-clamps are the maintenance walkway support arms. Two clamps support each arm; one on the front and one on the back. The critical of these two is the front. When this support is lost (broken C-clamp) the walk arm can rotate around the back chord and is no longer supported (depicted below).

This is the reason that the maintenance walkway should not be utilized until all crack/broken C-clamps are replaced. Of particular concern are all front clamps. After replacement, a general inspection is still recommended prior to each use of the maintenance catwalk. During the design of the first overhead sign support (1960's) the main reason for the catwalks was to provide support for lighting and access to allow sign re-facing (overlay). Due to today's long life span of sign reflective sheeting signs no longer require lighting and/or re-facing. Based on this we recommend all catwalks be removed. This will dramatically reduce ongoing maintenance, reduce the dead load on the support and inhibit further vandalism.

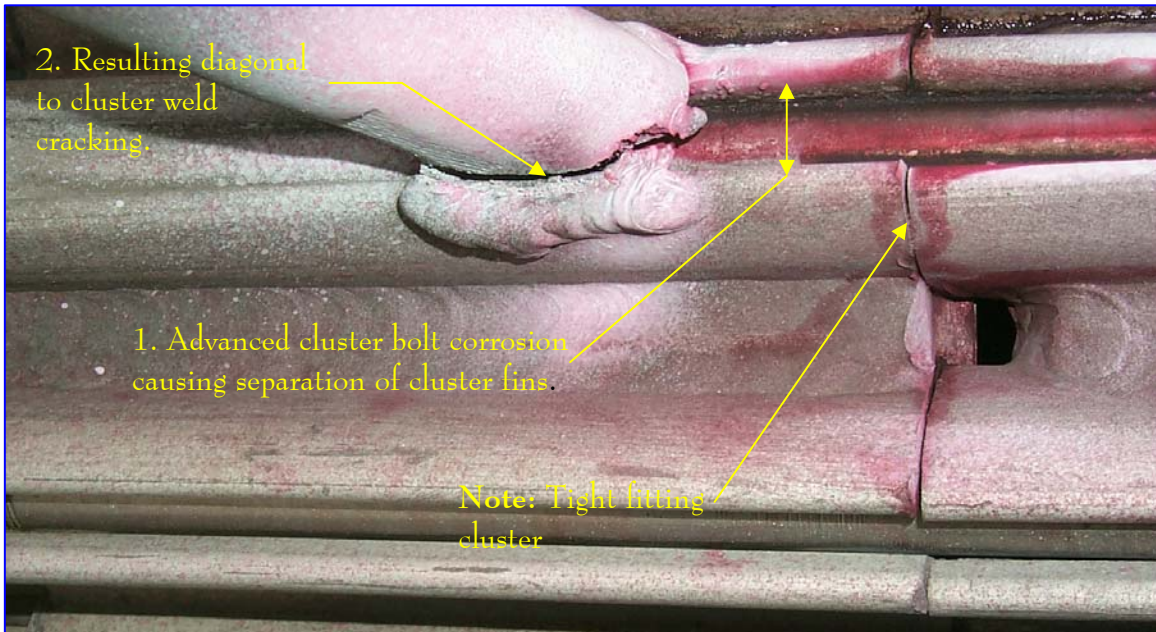
As documented in previous reports and as seen in this report, several structures have advanced cluster bolt corrosion resulting in extensive diagonal to cluster weld cracking. The below photograph generally describes this area:

This problem typically occurs in the lower horizontal clusters of older ATL and ACL structures. One factor that affects the advancement of this cracking is the degree of water tightness between the two adjoining clusters. A tight fitting connection retains water, which increases the rate of deterioration of the cluster bolt. For each site-specific condition refer to the individual inspection summaries.

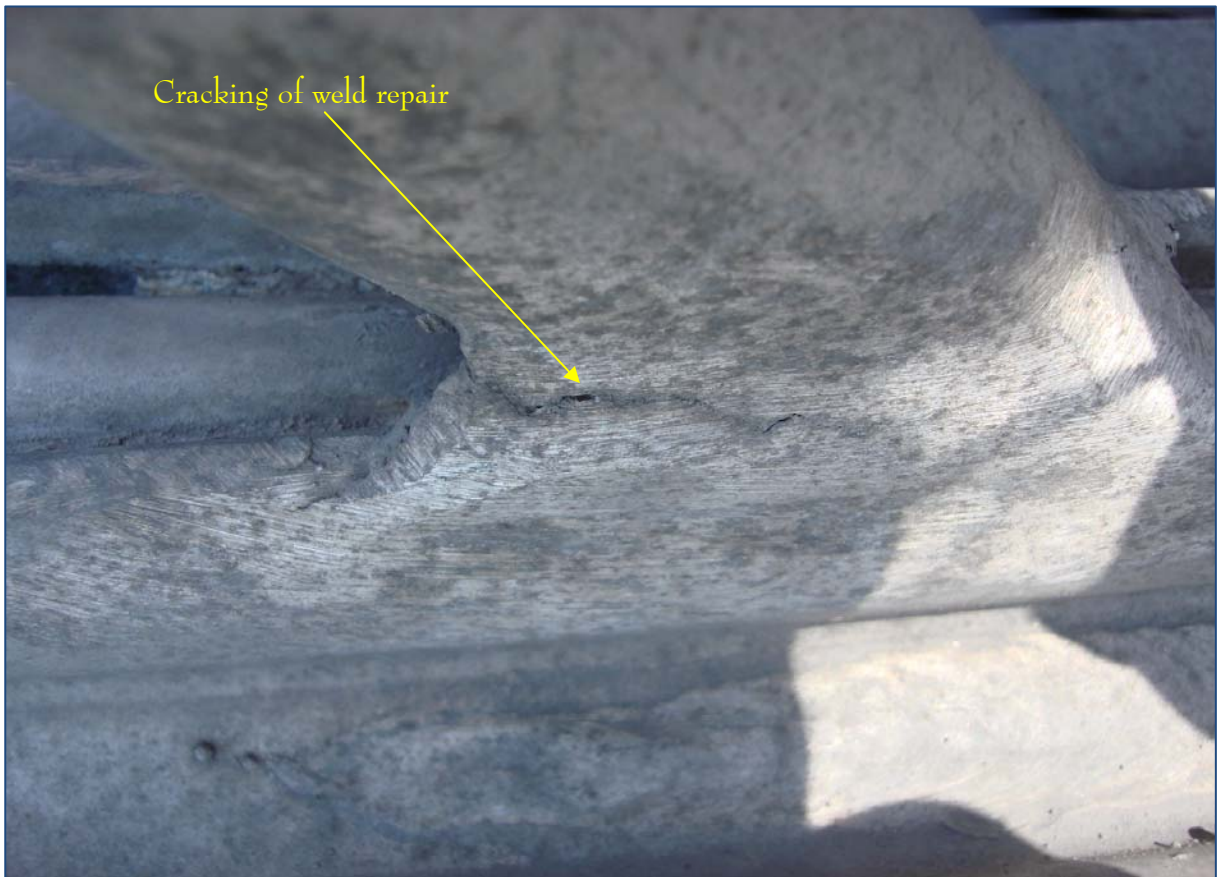
The below photograph depicts further weld cracking of this area after repairs were completed in a relatively short time period. Continuing corrosion build up between the cluster bolt and the fins is causing the fins to further separate. This results in on-going weld cracking and continuous weld repair. To eliminate the need for this on-going repair work it is recommended that this area be modified.

As previously mentioned, this problem mainly occurs for the ATL and the ACL. Historically this is because the ARL have not been in service long enough to allow for the cluster bolt corrosion. However, several ARL supports have started to show initial signs of this issue. It is recommended that this area be modified to eliminate on-going maintenance needs and possible failure.
