City of Hamilton

# 2017 Sign Support Inspections Summary Report

**Project No: 60554463**

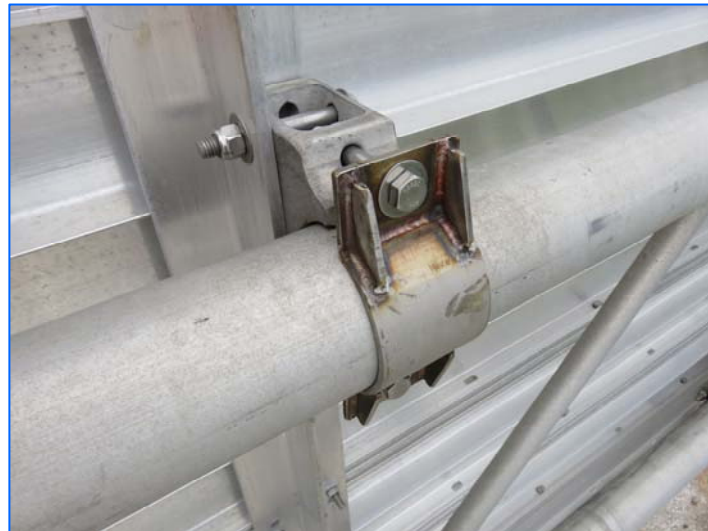
Re-design of the sign clamp should be considered to eliminate on-going clamp replacement and reduce the risk of injury. One design by Burgess Engineering Inc. that has been successfully installed is depicted:

This is the reason that the maintenance walkway should not be utilized until all crack/broken C-clamps are replaced. Of particular concern are all front clamps. After replacement, a general inspection is still recommended prior to each use of the maintenance catwalk. During the design of the first overhead sign support (1960's) the main reason for the catwalks was to provide support for lighting and access to allow sign re-facing (overlay). Due to today's long life span of sign reflective sheeting signs no longer require lighting and/or re-facing. Based on this we recommend all catwalks be removed. This will dramatically reduce ongoing maintenance, reduce the dead load on the support and inhibit further vandalism.

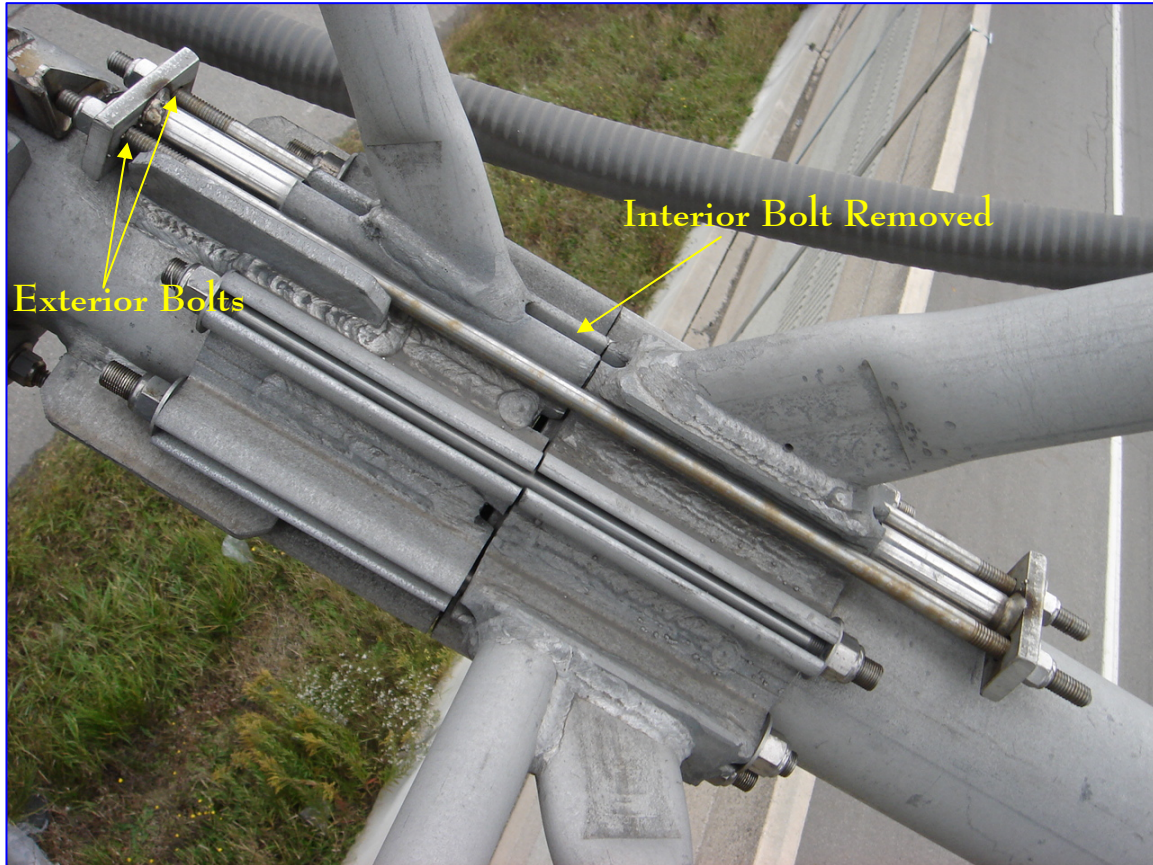
As previously mentioned, this problem mainly occurs for the ATL and the ACL. Historically this is because the ARL have not been in service long enough to allow for the cluster bolt corrosion. However, several ARL supports have started to show initial signs of this issue. It is recommended that this area be modified to eliminate on-going maintenance needs and possible failure.

One approach as designed by Burgess Engineering Inc. is depicted below. This was successfully completed on several MTO, Advanced Traffic Management ARL.

In this approach the bolt that corrodes and causes the weld cracking is removed and replaced with two exterior bolts. It should be noted that at the time of this retrofitting all damaged and cracked areas should be repaired. Once this is completed the need for on-going weld repair will be eliminated.
